Castlefield, Bolsterstone, South Yorkshire Excavation Autumn 2008

Interim report prepared by:
Tim Cockrell
(with contributions by C. Cumberpatch and W. Goodhind)

Bolsterstone Archaeology and Heritage Group

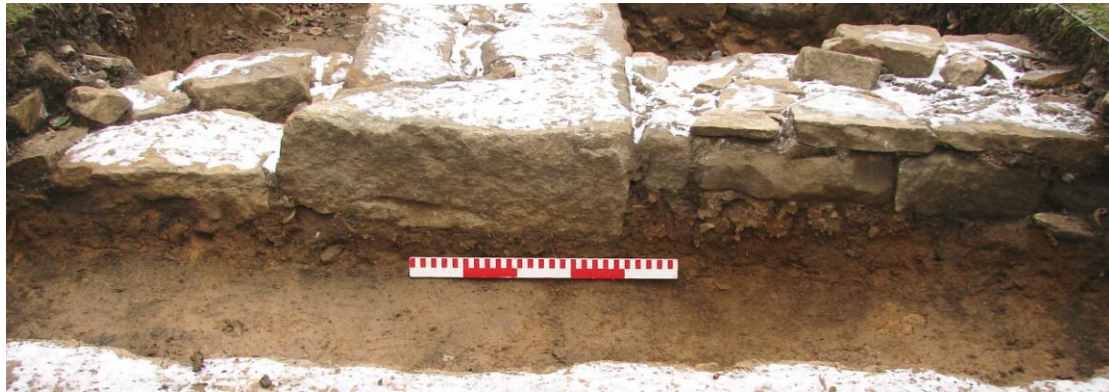
Plate 1, The outer face of the exterior west wall, looking east.

was excavated along the edge of the walls. Bedrock was not encountered, but the bottom of the walls defined. This revealed that walls 1010 and 1018 (the wall going into the north section of the trench) were constructed to the same depth, but that 1005 was bedded in to a shallower depth (see plate 1, and elevation drawing 2). The construction of wall 1005 also appeared different, with smaller slabs being used in the construction of its outer faces, than those used for 1010 and 1018 (see plate 4, and final plan).

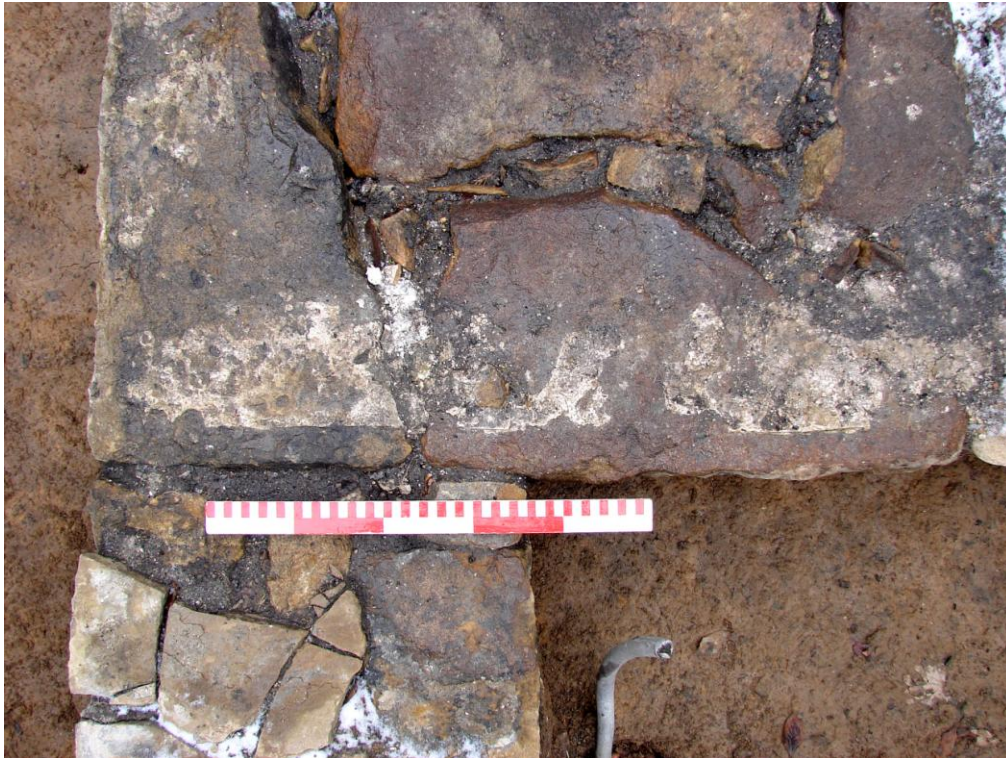
Plate 2, floor surface (1036) above the west end of wall 1010.

When the tops of the wall sections were cleaned it was also clear that mortar-like material survived on all walls (including wall 1013, but not wall 1031 in the eastern part of the trench (see below). However, what at first appeared to be mortar in some quantities on wall 1010, underlying surface 1009, was later shown to have a distinct and very sharply defined edge running the length of the wall (C. Merrony, pers. comm. See plates 2 and 3 below), but set back somewhat from the edge of the wall. It was clear that this could not be building mortar or pointing, but had been laid across the top of the wall (as it then was) against a structure or feature with a distinct edge, of which no trace survives. A close examination of the edge of this surface further revealed that part of this material had leaked or oozed under whatever structure had been there (see plate 3).

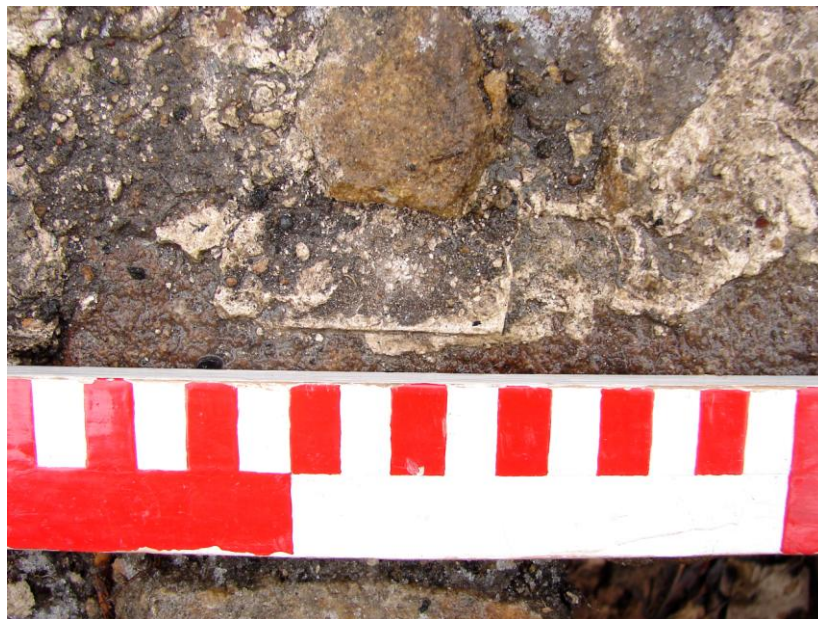
Plate 3, detail of plate 2

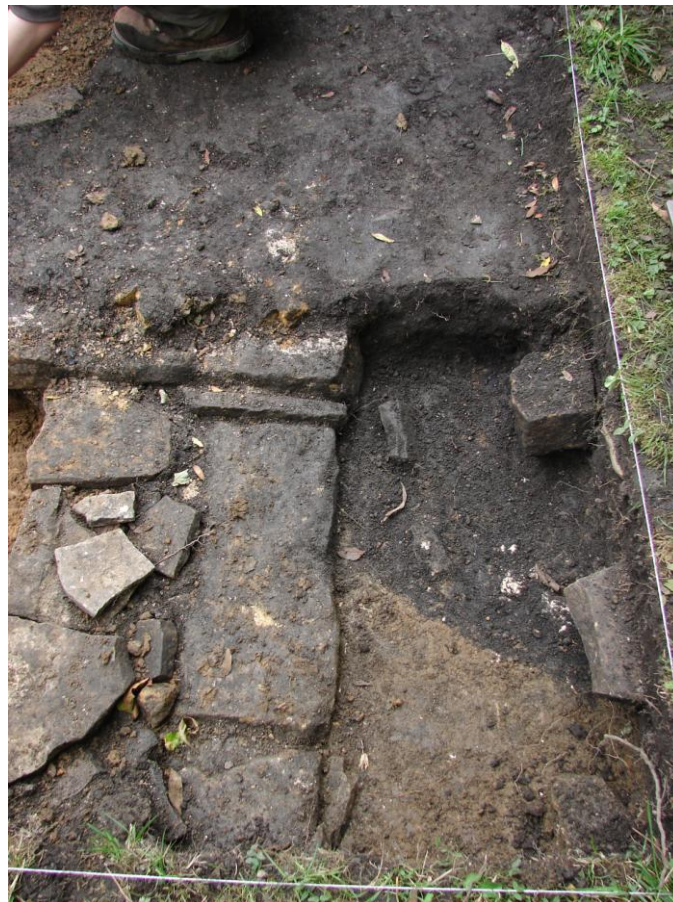
Plate 4, wall 1013(bottom left), context 1014(bottom right), cut 1035 with fill 1022(middle right), surface 1009 overlying wall 1010(top). Foot at top for scale.

The edge of this cut ran north-south, at right angles to wall 1010, and apparently lining up with the west edge of wall 1013 to the south of wall 1010 (see plate 4). This edge also met wall 1010 where two large blocks of masonry lay beneath 1010, apparently forming part of the east end of the wall, but in fact differing in their size, position, and configuration sufficiently to interpret them as an earlier phase of construction. These blocks (context 1031) protrude from the rest of the wall, and align in a slightly different direction, as can be seen in the final plan, and plate 8. They also lie in cut 1029, which no doubt form part of the footings for whatever structure they were part of. It is possible that cut 1029 extends beneath 1010, and beyond, under 1013, which would explain the presence of rubble at the bottom of that wall noted above.

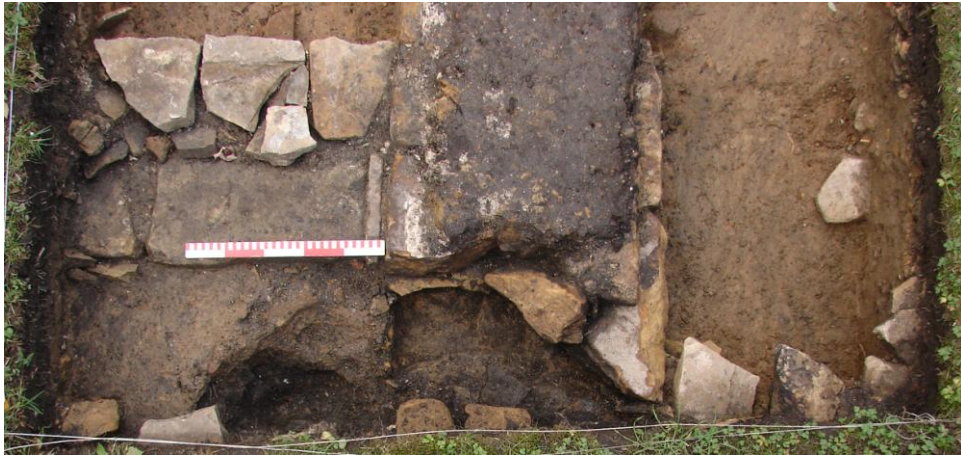
Plate 5, showing the east end of the trench. Cut 1035 has had fill 1022 removed, and most of 1028. Shallow cut 1029 is visible to the right of the picture, with wall context 1031 immediately to its left.

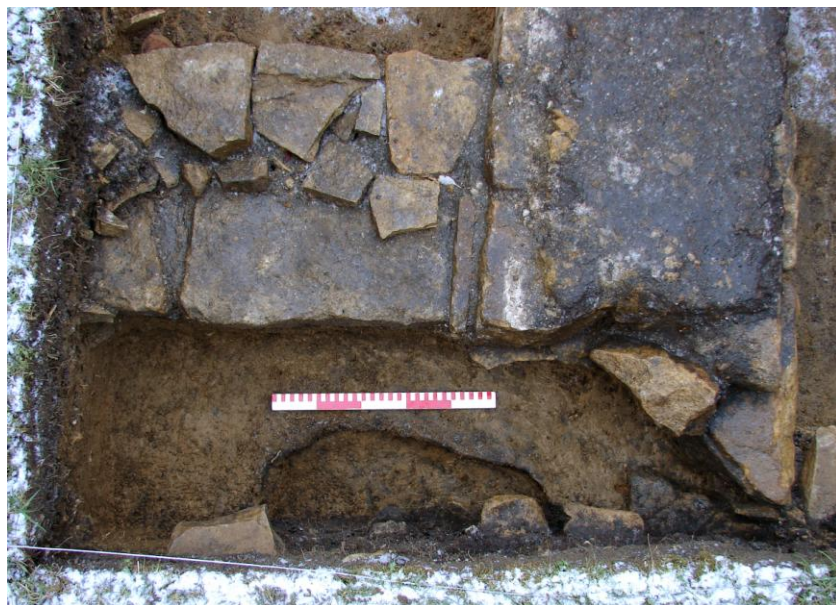
Plate 6, the bottom of cut 1035, dug into the surrounding natural clay, after the removal of subsoil contexts 1023 and fill 1028.

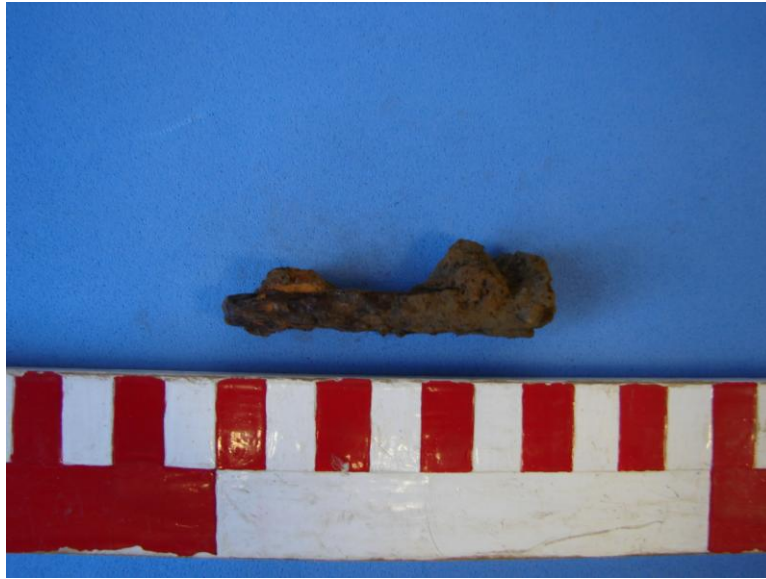
Plate 7, case 27 from table 1, rectilinear rod

Identifiable ferrous artefacts included hinges (case 4, from context 1001, and case 265, from context 1010), a nut and bolt (case 3, from context 1001), a screw (case 34, from context 1006), fragments of sheet metal, and a number of sections of bar or rod (plate 7). The overwhelming majority however were nails. They came in various lengths and thicknesses, but are mostly between 20-40mm long and are square shaped in section.

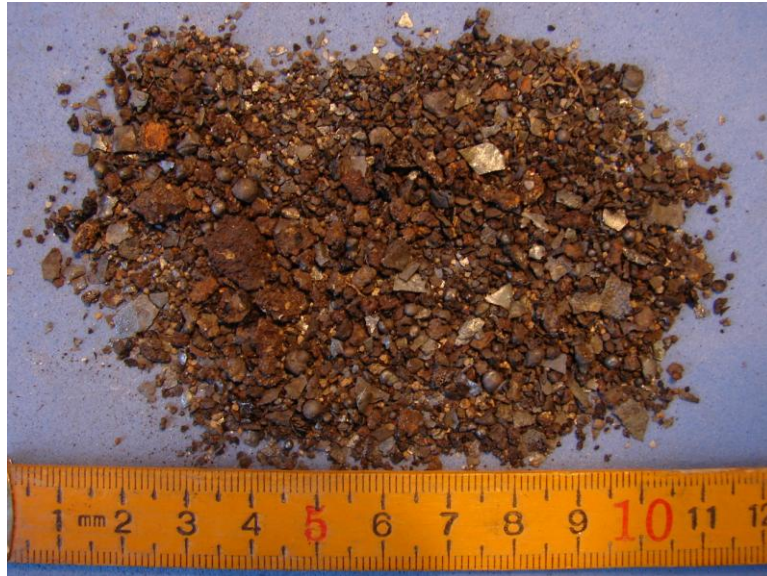
Plate 8, Hammer scale recovered from context 1022

A major artefact type to be recovered from the site was hammer scale. This material was recovered from the soil by the use of a magnet, and was not otherwise discernible in most contexts. It was randomly sampled from contexts 1001, 1002, 1003, 1006, and 1010. In addition, a particularly high concentration was recovered in large quantities from context 1022, in cut 1035, along with highly magnetized irregular pieces of indeterminate nature (case 216, table 5), and slag (see below). Confirmation that the gritty magnetic material recovered was hammer scale came after detailed examination took place upon completion of graded wet sieving of the material (plate 8). Curiously, hammer scale was entirely absent in the west end of the trench below the topsoil layers 1001 and 1002. However, this area lies outside of the main workshop, and as such, this absence reflects the different character of use in this part of the site.

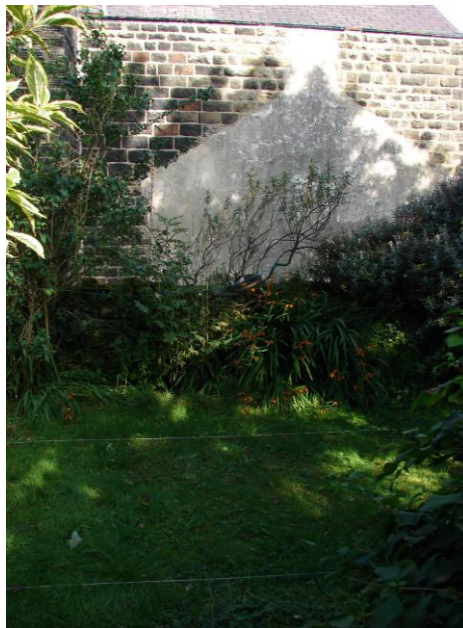
Plate 12, north end of the main building, and marked out trench in the foreground.

The site was investigated by the excavation of a single trench of 2 metres by 4 metres. The trench was sited to take in the interior of part of the former building along its long axis running north-south, bisecting it at right angles, and incorporating the line of the former exterior west wall. The remainder of the trench included the likely location of either a yard area to its west, or part of the west wing, the “stable”, (see figure 2). The task of situating the trench was greatly eased by the existence of an impression of the north end of the former building, preserved in the south wall of the adjoining property, “Castle Green”(see plate 12).

This area is known to have been very close to the location of both the anvil and the southern hearth as they existed in the last phase of the building's existence (S. Clegg; P. Dawson, pers. comm.). It is also claimed that a northern hearth existed (Rawlin 1999), which seems to be corroborated by the outline of its chimney stack, still visible at the northern end of the former building (plate 12 below).

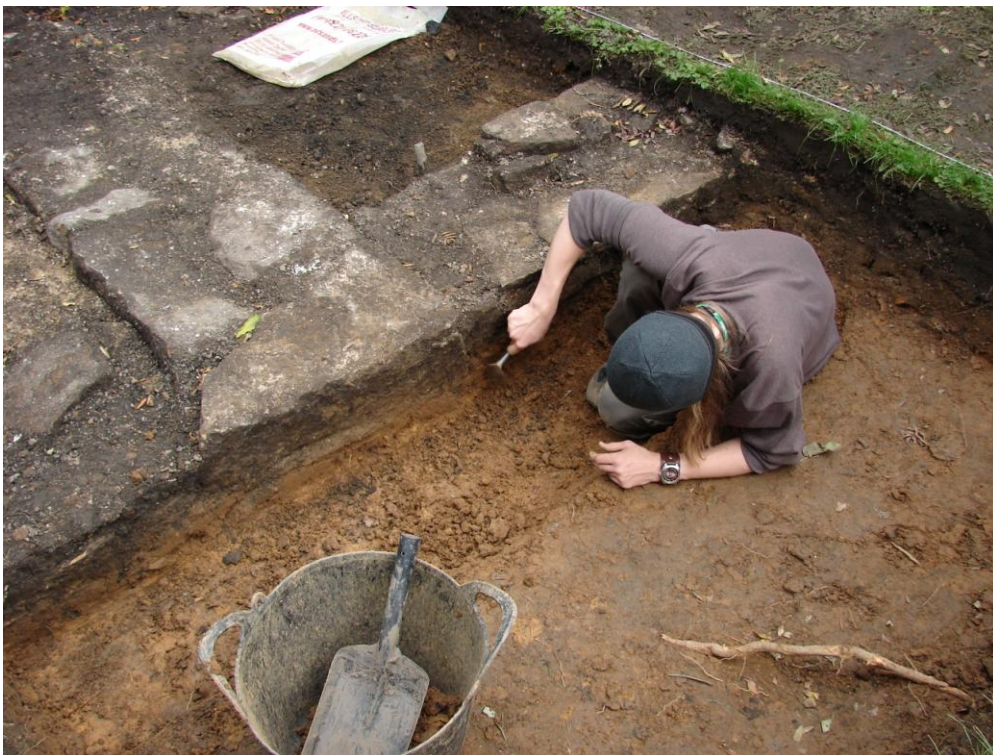
Plate 17, Ryan Wilson excavates a sondage to reveal the bottom of walls 1005(to his right), 1010, and 1018 (left).

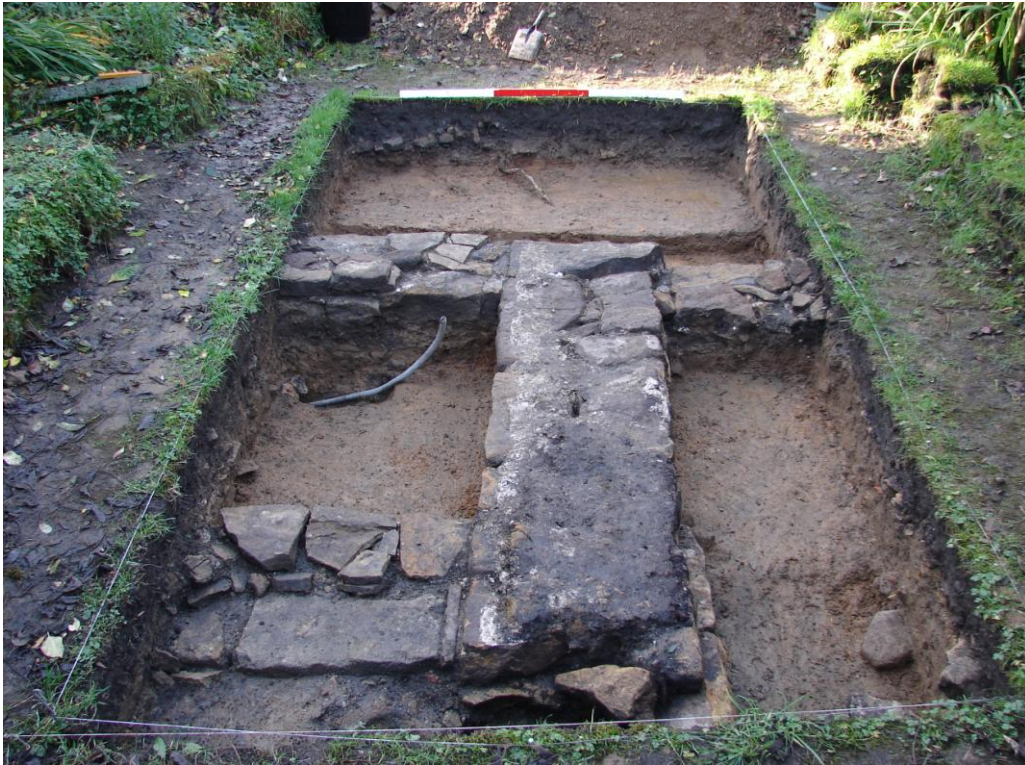
Plate 20, view west, showing the line of wall 1031, and its different configuration to that of wall 1010 above.

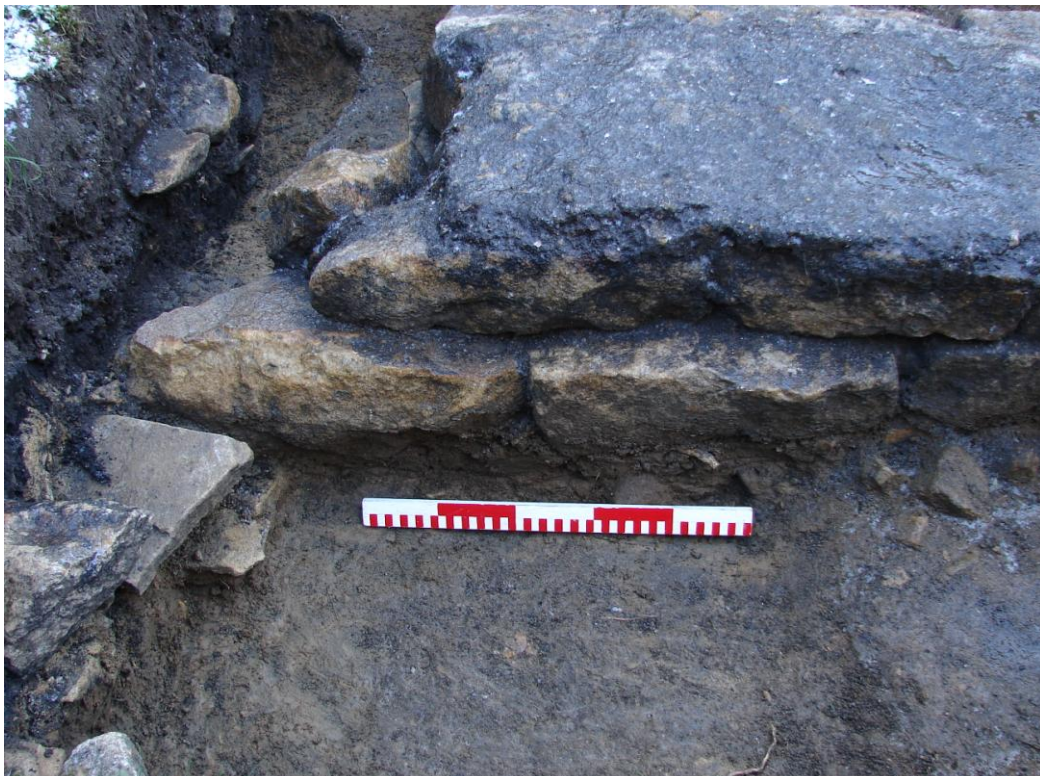
Plate 21, showing cut 1029, wall 1031, wall 1010, and concretion 1009.
